A BEACH MANAGEMENT MANUAL

A Beach Management Manual

Produced by the University of Malta within the framework of Project BESS (*Pocket Beach Management & Remote Surveillance System*), funded by the Interreg Italia-Malta funding mechanism of the European Commission. The production of the methodological approach for beach management plan development and formulation of three case studies was carried out in collaboration with Adi Associates Environmental Consultants Ltd (Malta).

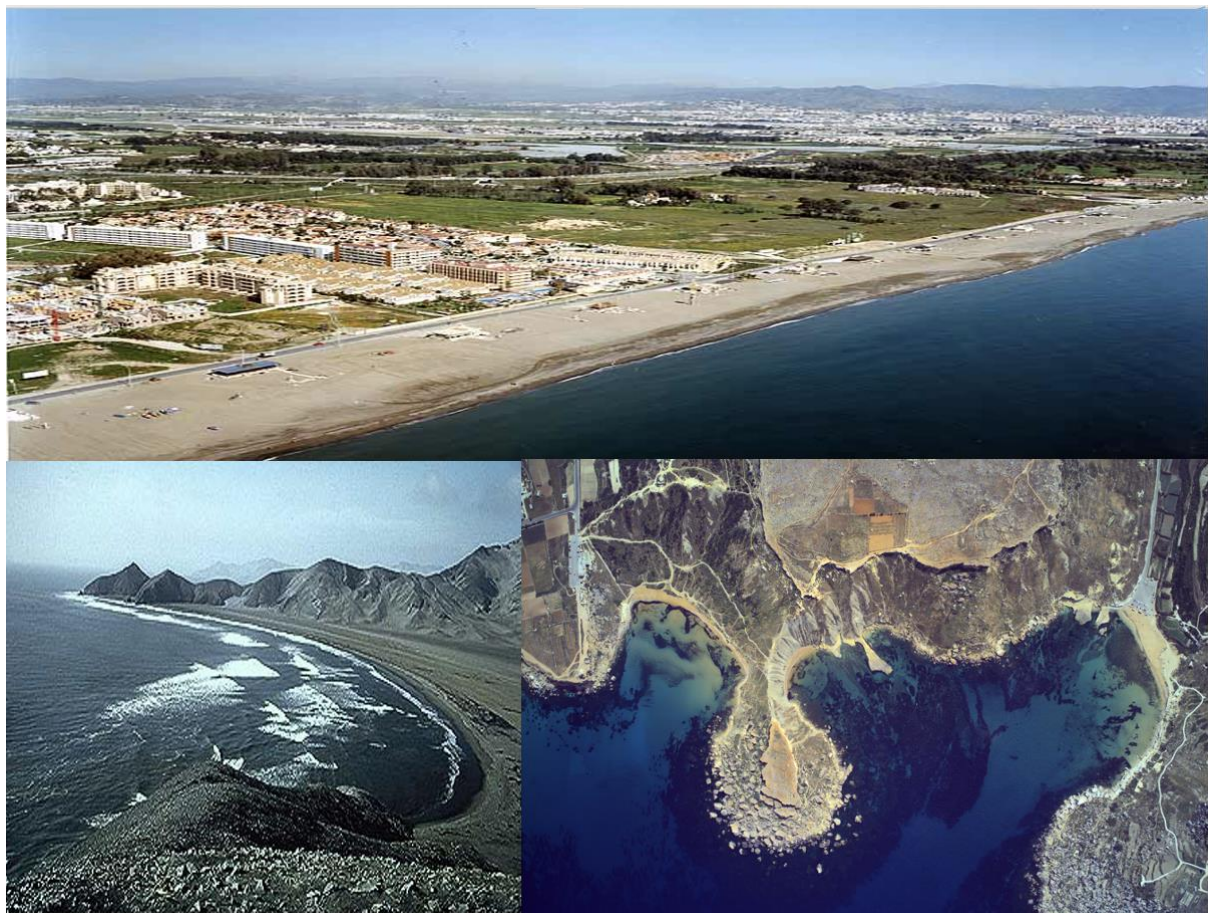
Studies based on beach morphological characteristics have referred to two main types of beaches, namely those dominated by along-shore drift (producing *linear beaches* on open coasts), and swash dominated beaches typically represented by smaller *pocket beaches* that bounded by headlands (Williams & Micallef, 2009; Bird, 1996). Such pocket beaches are common to the Mediterranean, and typical of many beaches in Sicily and the only type found in the Maltese Islands. Davies (1980) further described a third beach-type which exhibits both swash and drift characteristics. The '*Zeta-form*' or fish-hook beach type is represented by only one headland which partially blocks long-shore sediment transport. This results in a swash dominated beach area in the lee of the headland, and drift dominated beach area down-drift of the headland (Figure 2).

Figure 2. A morphological classification of beaches, showing a linear beach (top), headland bound pocket beaches (bottom right) and a fish hook shaped beach (bottom left).

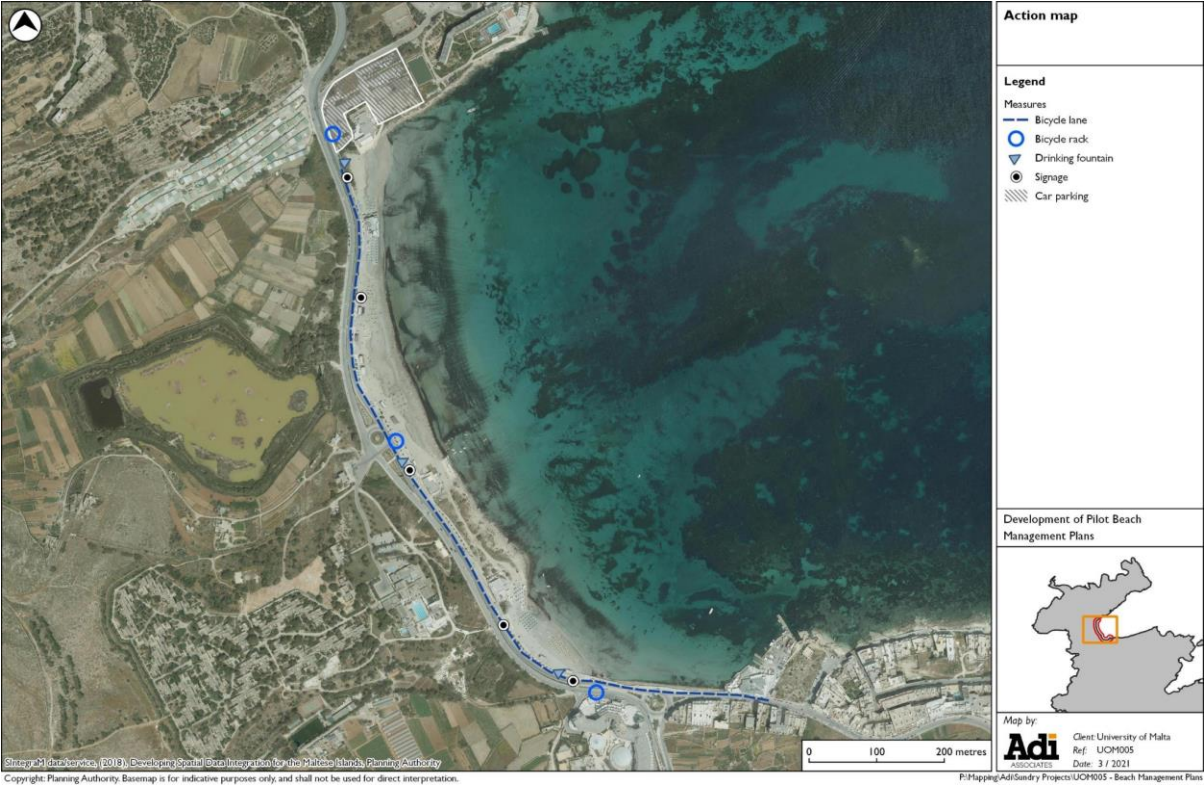
Figure 6b: Actions Map for Ghadira beach (land intervention: if promenade and road remain in place)

11.3 Improve and maintain the promenade and ensure access for all. Until a final decision is taken on whether to relocate the road or not, the promenade still requires some urgent attention in terms of improving the surface quality, ensuring accessibility and revisiting the alignment in places. A survey should be undertaken to determine where repairs need to take place and the works carried out accordingly.	High	MTA Infrastructure Malta

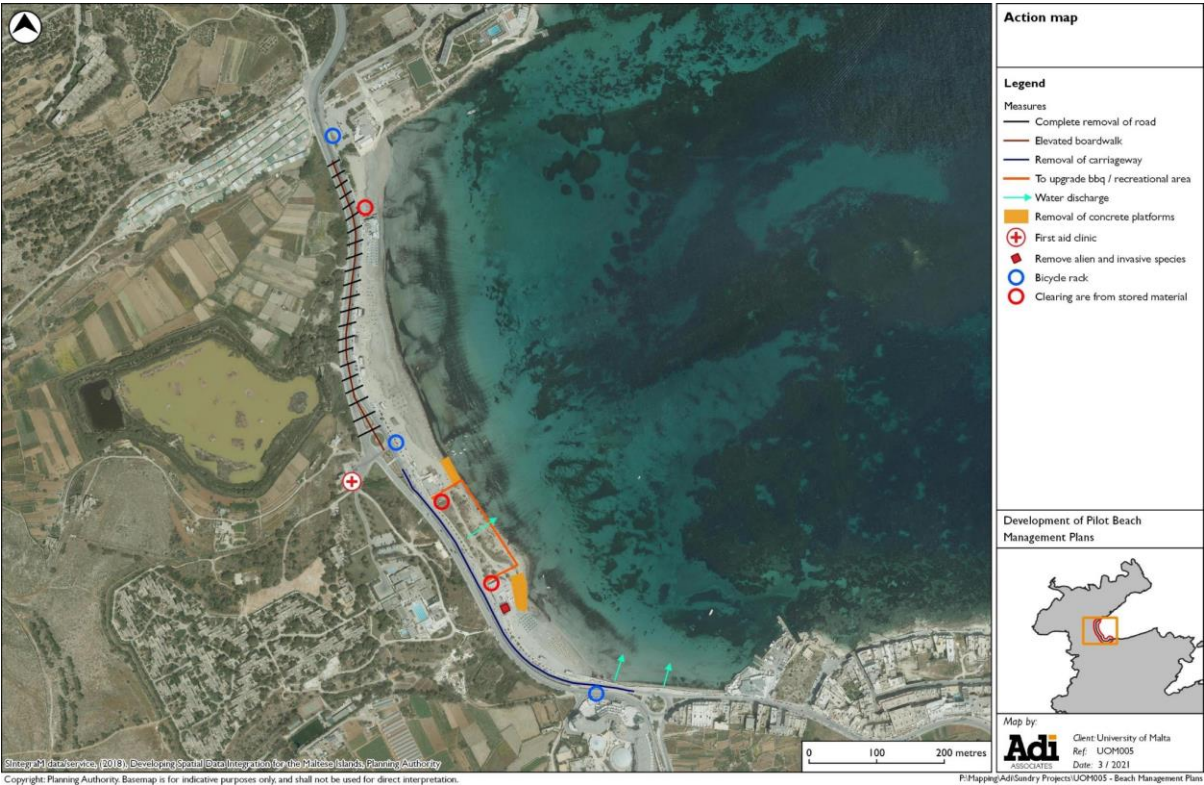
Figure 6c: Actions Map for Ghadira beach (land intervention: if promenade and road are removed)
